Accessible Pedestrian Crossing

A guided analysis of the corner of Hickory & Fry

Jamila Evilsizor | ADES 5420

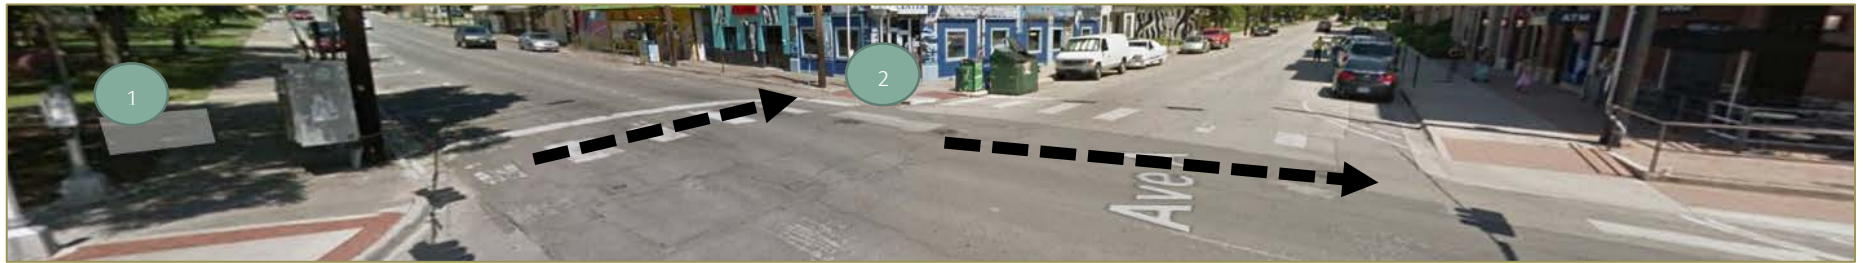
FIGURE 1 - THE SOUTH WEST, NORTH WEST AND NORTH EAST CORNERS

Below is picture of the intersection and available accessible pedestrian crossing features on the Southwest, Northwest and North east corners. The path of travel explored will be from the corner of UNT, north across Hickory, then east across Fry.

- 1 Southwest to Northwest - Push button integrated Accessible Pedestrian Signal, Curb Ramp, Tactile Arrow, Rapid Tick Indicator, Locator Tone
- 2 Northwest to Northeast – Push button integrated Accessible Pedestrian Signal, Truncated Dome, Curb Ramp, Ramp, Tactile Arrow
- 3 Northeast to Northwest – Push button integrated Accessible Pedestrian Signal, Locator Tone, Tactile Arrow, Curb Ramp with Truncated Domes
- 4 Northwest to Southwest – Push button integrated Accessible Pedestrian Signal, Locator Tone, Tactile Arrow, Rapid Tick Indicator, Curb Ramp

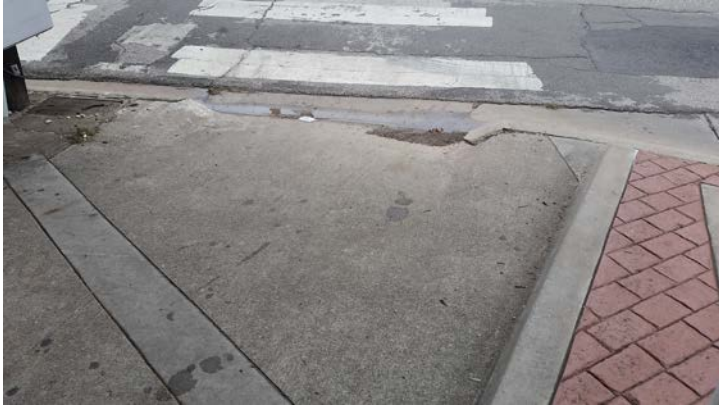
FIGURE 4 MISSING TRUNCATED DOMES

Summary: The Southwest to Northeast crossing has the minimum accessible pedestrian crossing features to determine when and in which direction to cross. The lack of truncated domes prevents Leila from knowing with complete certainty when she has entered an area of danger. Additionally, the curb ramps are not within the bounds of the crosswalk, so walking in a straight line prevents her from reaching the opposing curb ramp without error.

Recommendations for Improvement: Adding truncated domes will ensure the visually impaired do not enter the street too soon. Additional street geometry indicators, activated through the pushbutton can ensure she aims to her left as she's crossing to reach the appropriate curb ramp

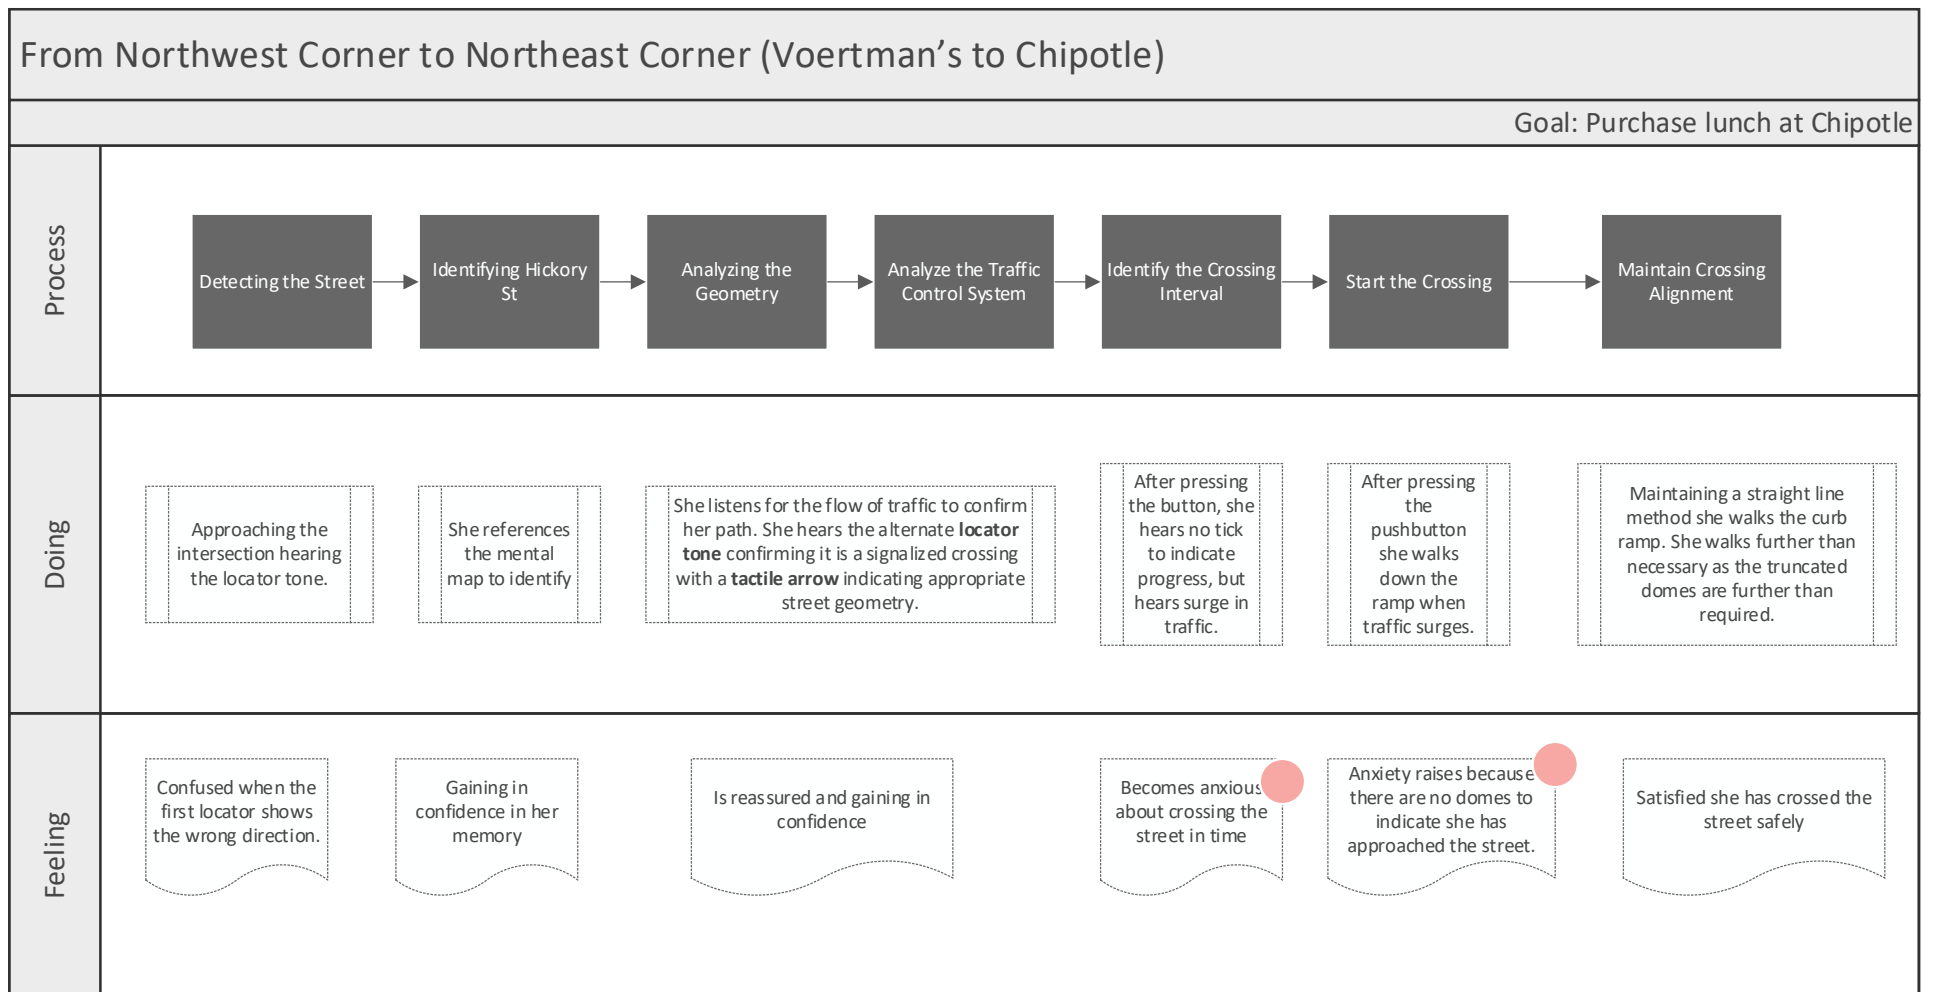
Experience Map & Analysis – Crossing from Voertman’s to Chipotle

Summary: The initial locator tone at this intersection is for the crossing towards UNT. There is another locator tone at a lower decibel, but it is currently in sync with the louder one making it harder to hear. The Northwest to Northeast crossing does not have truncated domes to aid in knowing where you may begin to cross. While Leila could try to stay further back from the road to ensure her safety, the lack of a walk indicator means it will take her longer to cross the street than necessary since she is not starting from the optimal distance.

Recommendations for Improvement: Truncated domes will ensure the visually impaired do not enter the street too soon. Also, equipping the pushbutton indicators with a rapid tick signal or other walk indicators ensures she crosses at the most appropriate time.

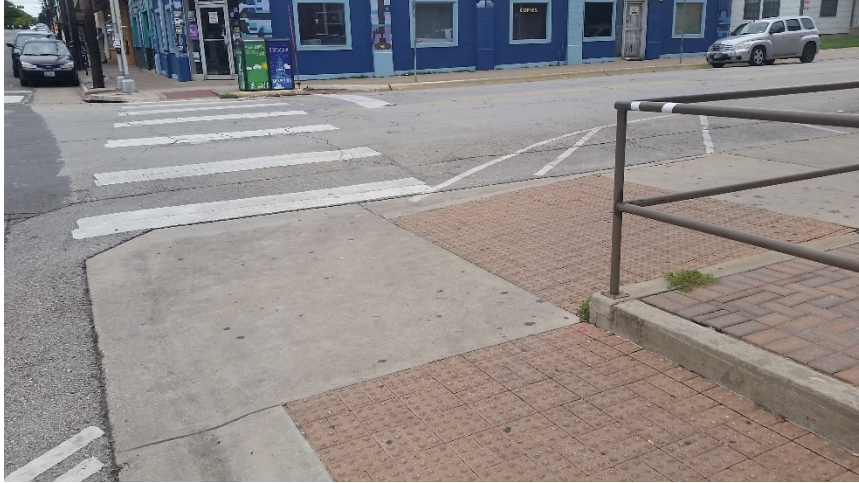
FIGURE 5 TRUNCATED DOMES EARLY TERMINATION

Summary: The Northeast to Northwest crossing has truncated domes that terminate prior to the start of the street. Unbeknownst to Leila, she is starting her crossing further back than necessary. Once again she will encounter an intersection that fails to alert her to with a walk indication, presenting similar timing concerns as her previous trek across Fry St.

Recommendations for Improvement: Add truncated domes to the remaining portion of the curb prior to the beginning of the street. Add a walk indicator to inform the pedestrian when it is appropriate to walk. Unfortunately, moving the pushbutton indicator so it is a more optimal position in relation to it's counterpart and also in relation to the doors of Chipotle may require a larger investment to overhaul the current physical infrastructure.

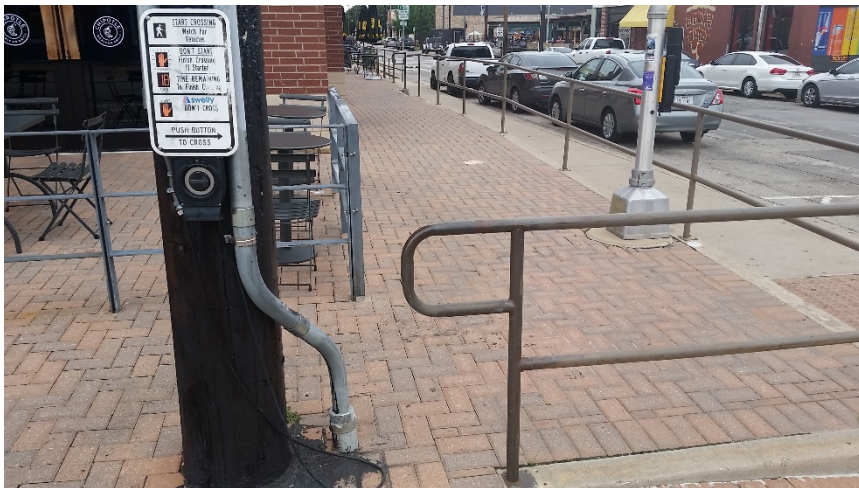
FIGURE 6 PUSHBUTTON LOCATIONS

Complications: The NE to NW corner pushbutton is more difficult to find depending upon which door is used to exit Chipotle. The pushbutton is difficult to locate if exiting from the West exits. If you exit from the West, the initial locator tone will direct you to the wrong street. When attempting to find the other locator button, you will notice it is inaudible from your current position. There is also a street pole, small clearance, and a ramp pole that will impact your travel to find the other pushbutton indicator. The alternate pushbutton is over 10 feet away, more than the ADA standard distance, from the current one found.

If you exist from the South, only the South crossing pushbutton is audible, and the West crossing is impeded by a bar if the button is accessed from the back (the area nearest. If the individual tries to leave from the South exit, they will need to follow the bar to the East (the opposite direction of travel) to go down the stairs then follow the bar West to the pushbutton, which is overshadowed by the locator tone for pushbutton for the South crossings. Tactile information is the most accurate way the individual could cross this street.
